State of Oregon
Department of Environmental Quality Memorandum

Subject: Schnitzer Investment Corp. Doane Lake Property File ECSI #395
Proposed Source Control Decision-Determination that Source Control Measure
Satisfactorily Performed.

Attachment A
**Doane Lake Cap Inspection Report
Photograph Log**

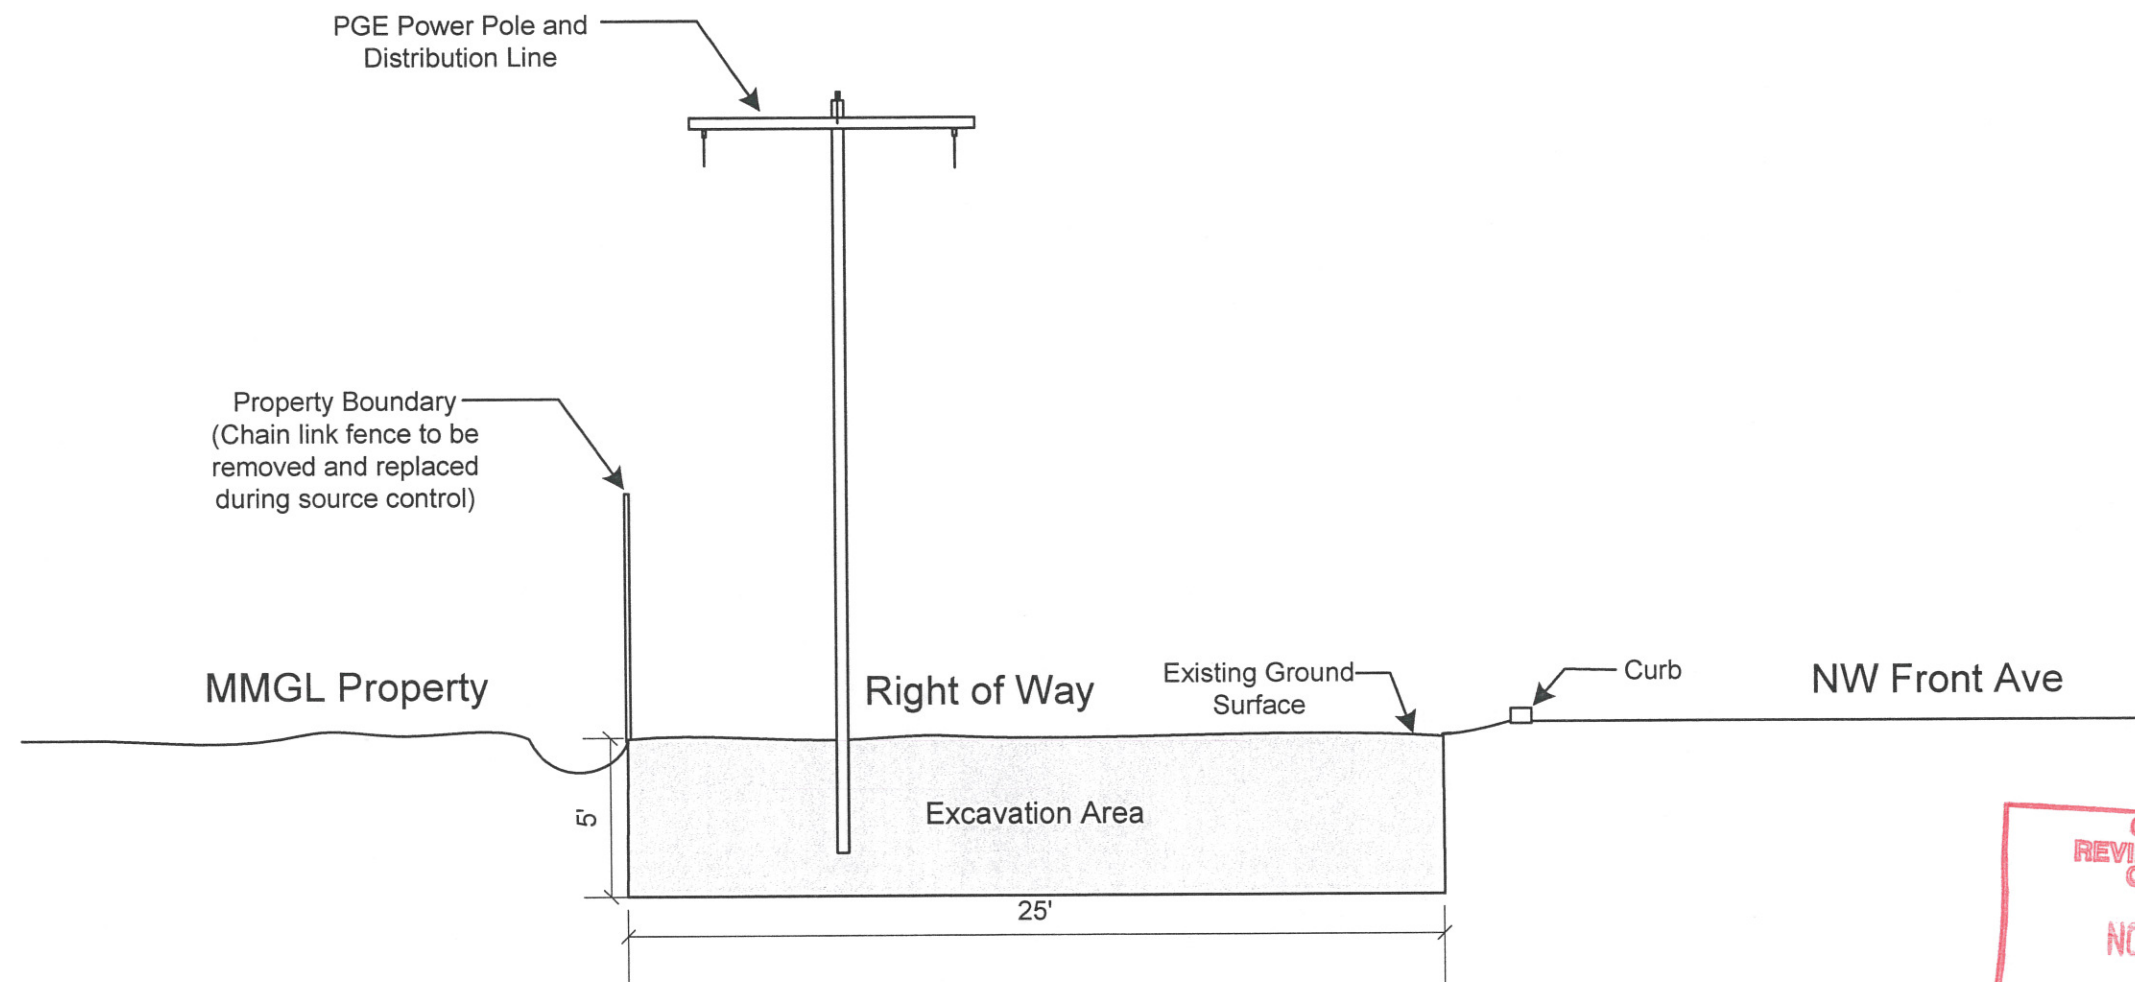
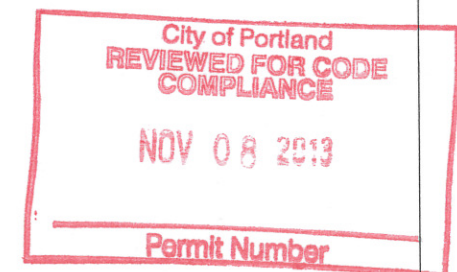
Figure 3
Excavation Area Profile View
MMGL Corp. Doane Lake Property

1. No known buried utilities
2. Excavated soil will be relocated to MMGL property

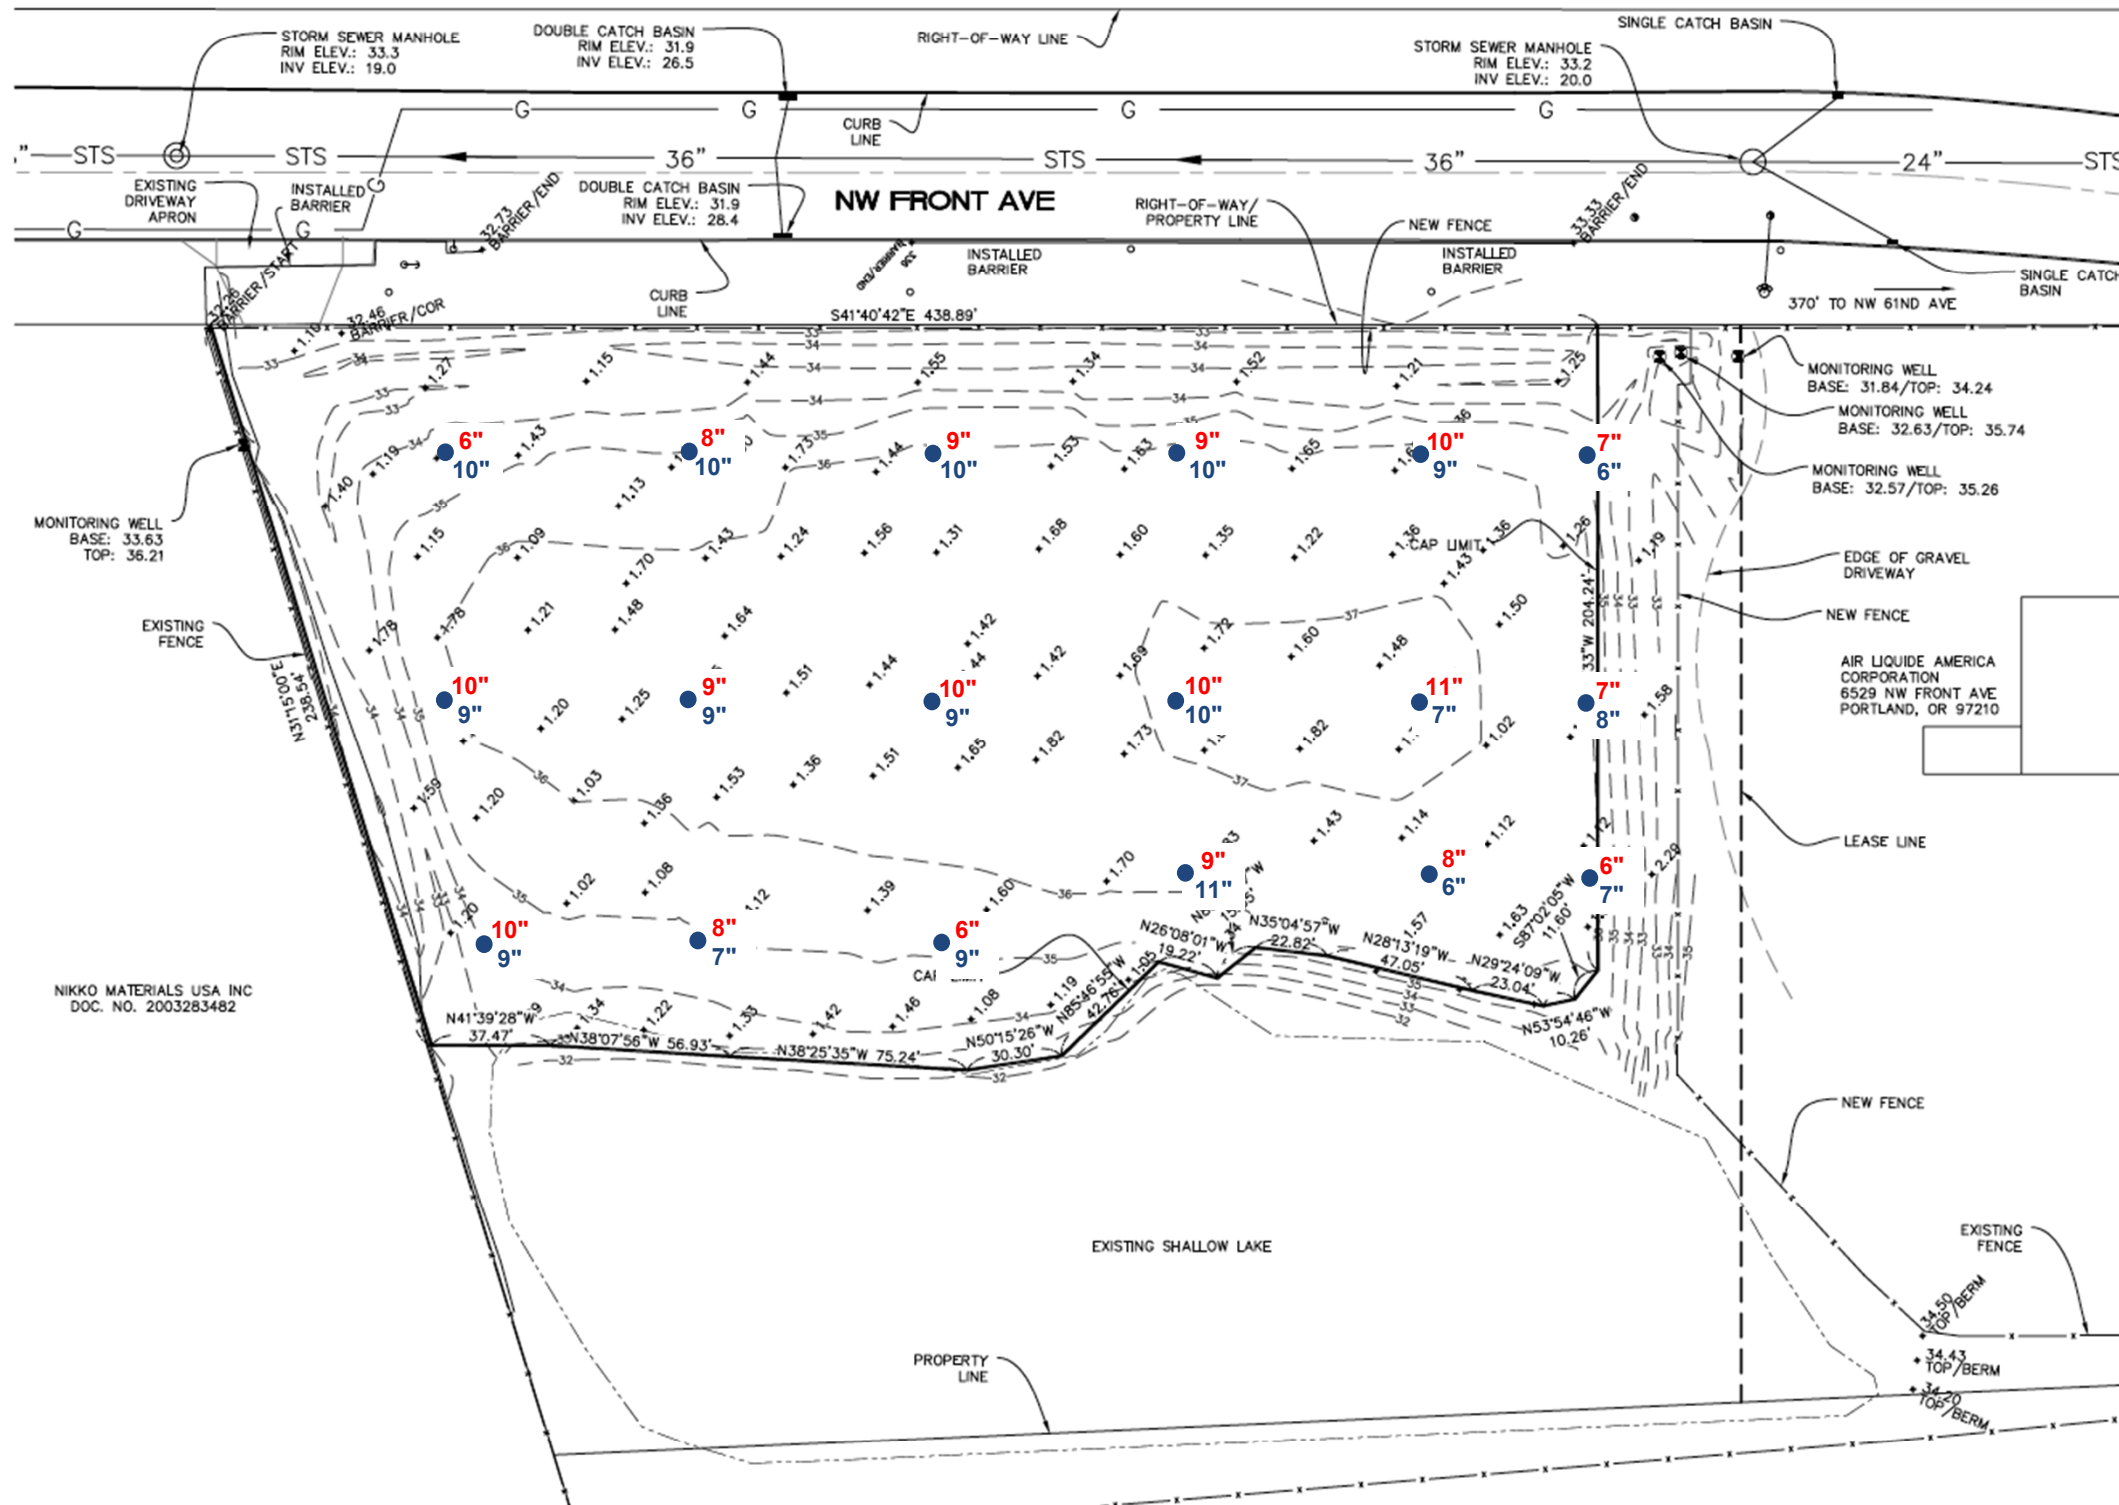
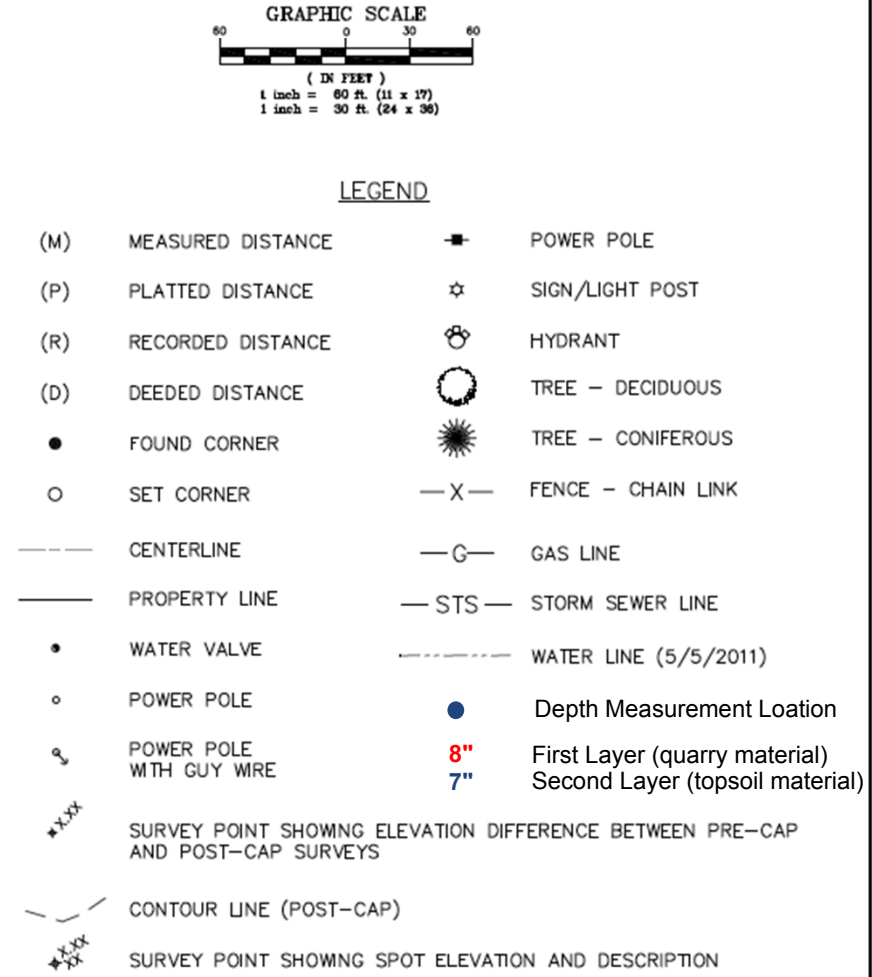
Figure 7
Initial and Final Layer Thicknesses
Doane Lake Source Control
MMGL Corp.

The impacted soil from the City Right-of-Way area was relocated to the central area of the Property to be capped. The southern portion of the Site was, on average, 2 to 3 feet higher in elevation than the northern portion so the high spots were loaded into an earthmover and graded across the northern portion of the Site. Lastly, the stormwater collection swales were constructed to allow for a minimum of 12-inches of clean imported quarry material or topsoil. 4,472 tons of quarry fill material was imported from Knife River quarry at 14545 NW St. Helens Road, Portland Oregon and graded to a minimum 6-inch depth. The quarry material consists of poorly graded silty sand with gravel. Quarry material also was used to raise the grade of the entrance and to build stormwater berms. 4,304 tons of sand loam topsoil was then imported and graded to a minimum 6-inch depth. R.A. Roth Construction & Sons Inc supplied the topsoil. MMGL received DEQ's approval on May 1, 2014, to utilize the topsoil. The laboratory analytical report documenting the non-contaminated nature of the topsoil was provided in the *Source Control Measures Completion Report* (Bridgewater Group 2015a), and is included in Attachment 4. Prior to placing the initial layer of quarry material, a demarcation layer consisting of Pro Silver nonwoven geotextile fabric was installed. Figure 7 of the *SCM Construction Report*

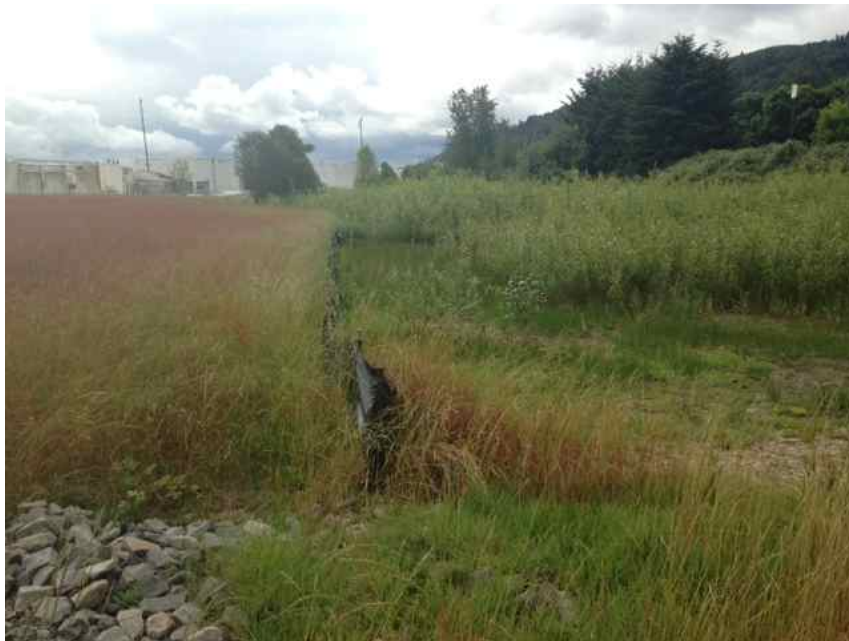
Doane Lake June 4, 2015. Northwest corner looking south. Remnant lake in right of photo.

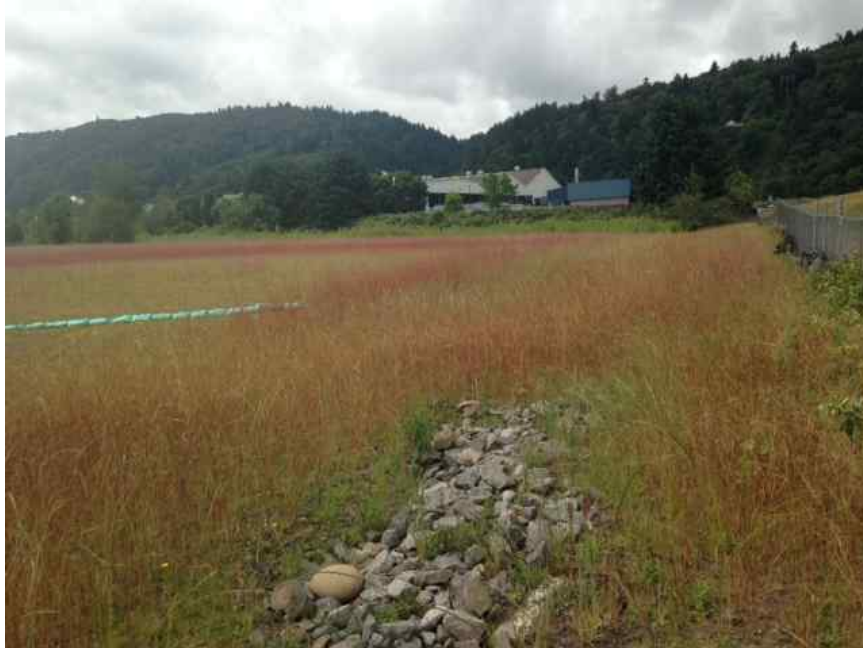
Doane Lake June 4, 2015. Northeast corner looking west.

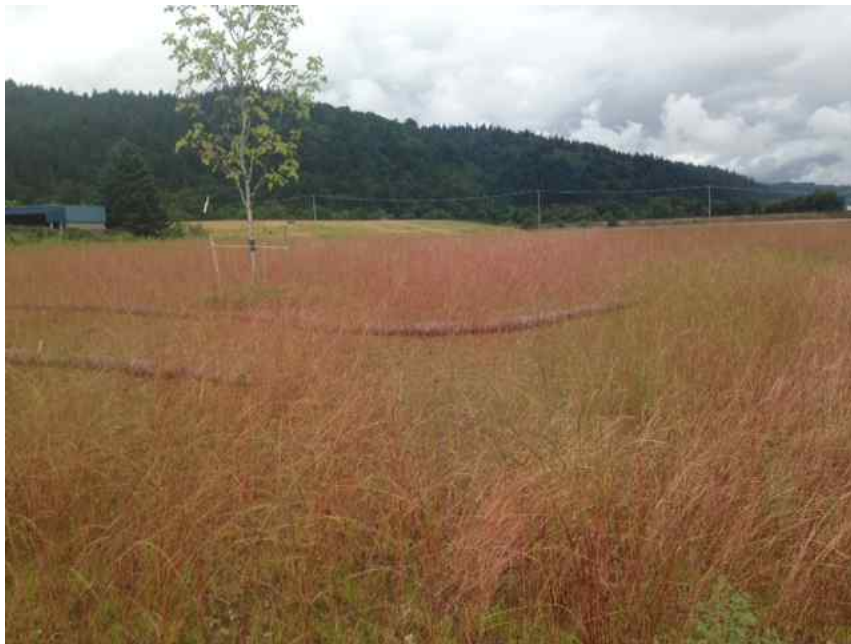
Doane Lake June 4, 2015. Southeast corner looking north.

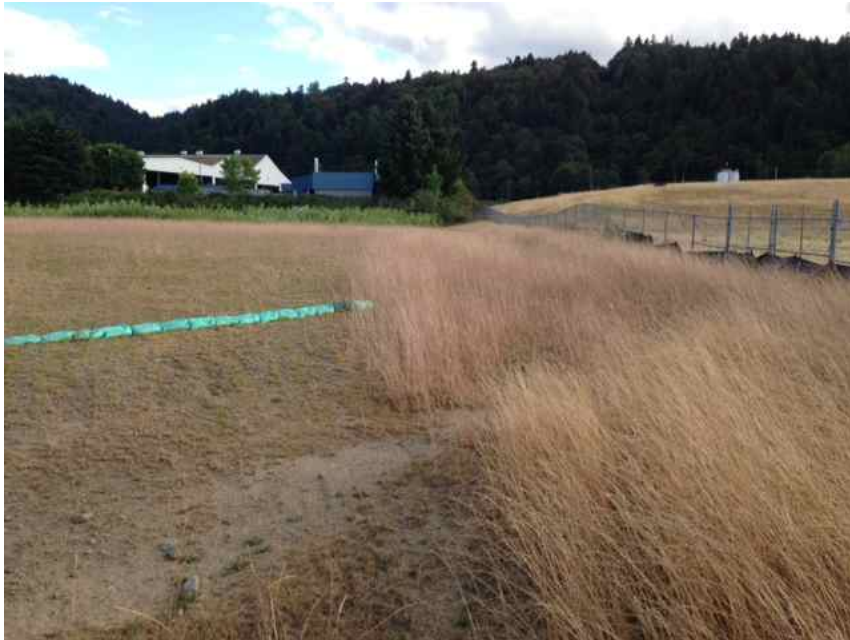
Doane Lake June 30, 2015. Northeast corner looking west.

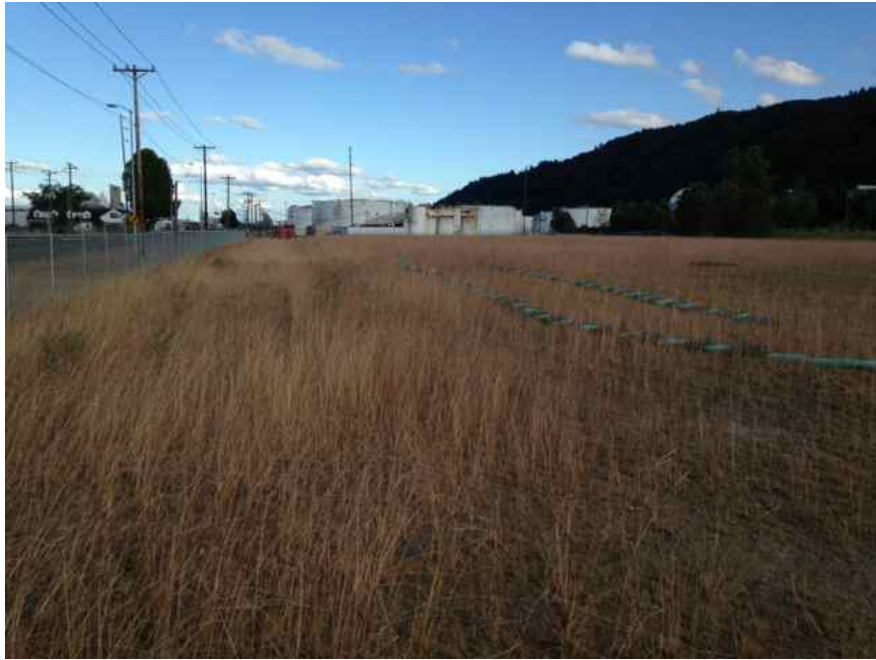
Doane Lake June 30, 2015. East swale looking south from northeast corner.

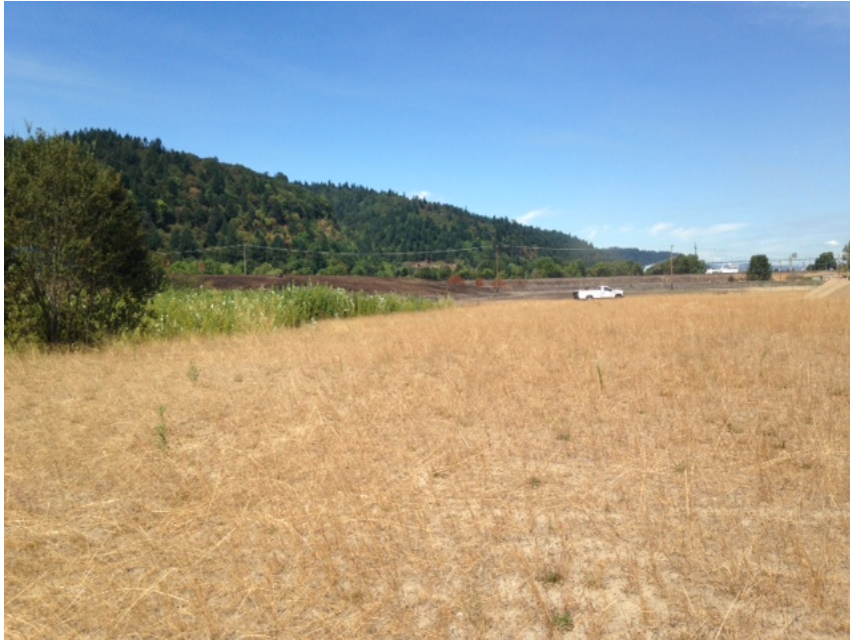
Doane Lake August 10, 2015. Southwest cap area, looking north.

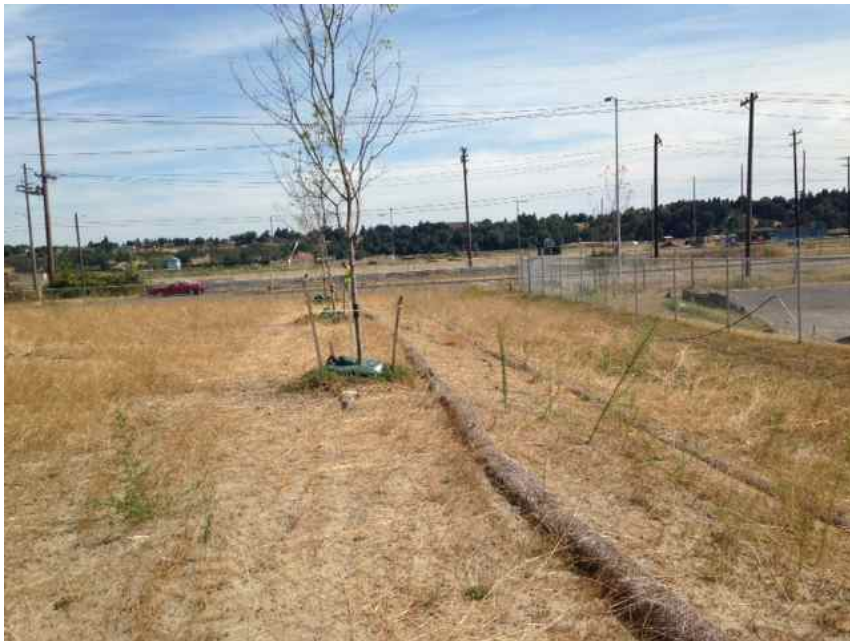
Doane Lake August 10, 2015. North swale looking east.

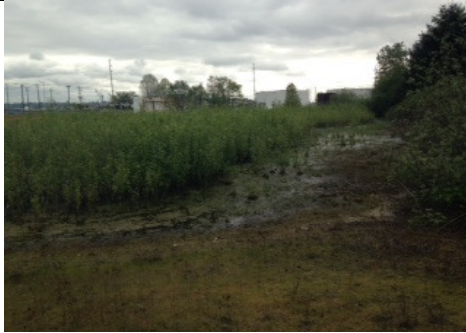
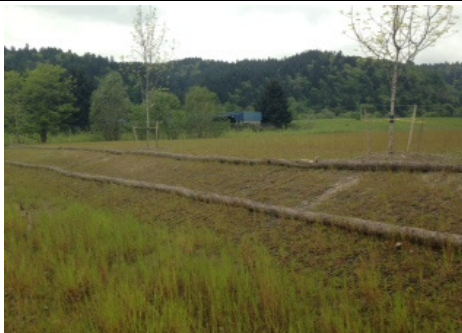
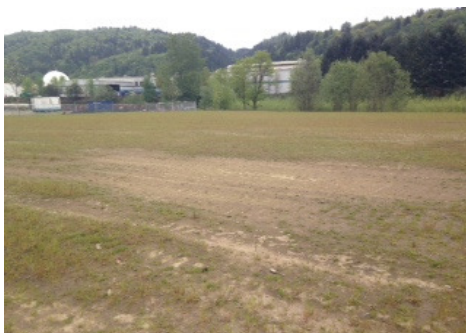
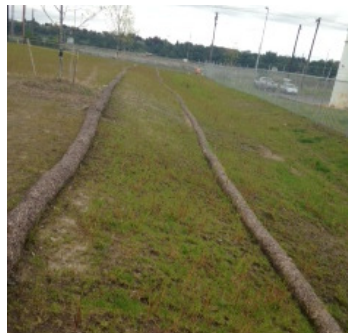
IF CORRECTIVE ACTIONS ARE NEEDED, IDENTIFY THE DATE THEY WILL BE COMPLETED: _Will fill eroded areas in the near future - researching fill provider options.

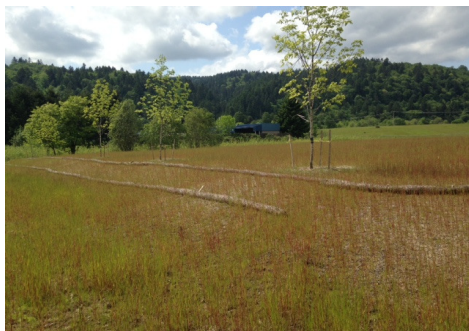
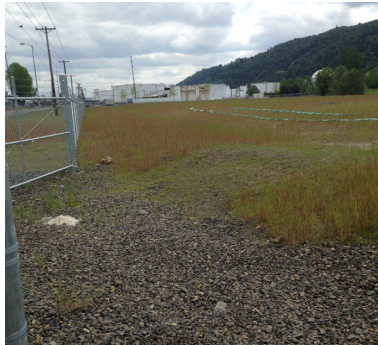
SILT FENCES: Standing. No issue noted.

DID ANY BMPs FAIL TO OPERATE CORRECTLY? No. Grass is growing in

IF CORRECTIVE ACTIONS ARE NEEDED, IDENTIFY THE DATE THEY WILL BE COMPLETED: _Will fill eroded areas in the near future - researching fill provider options.

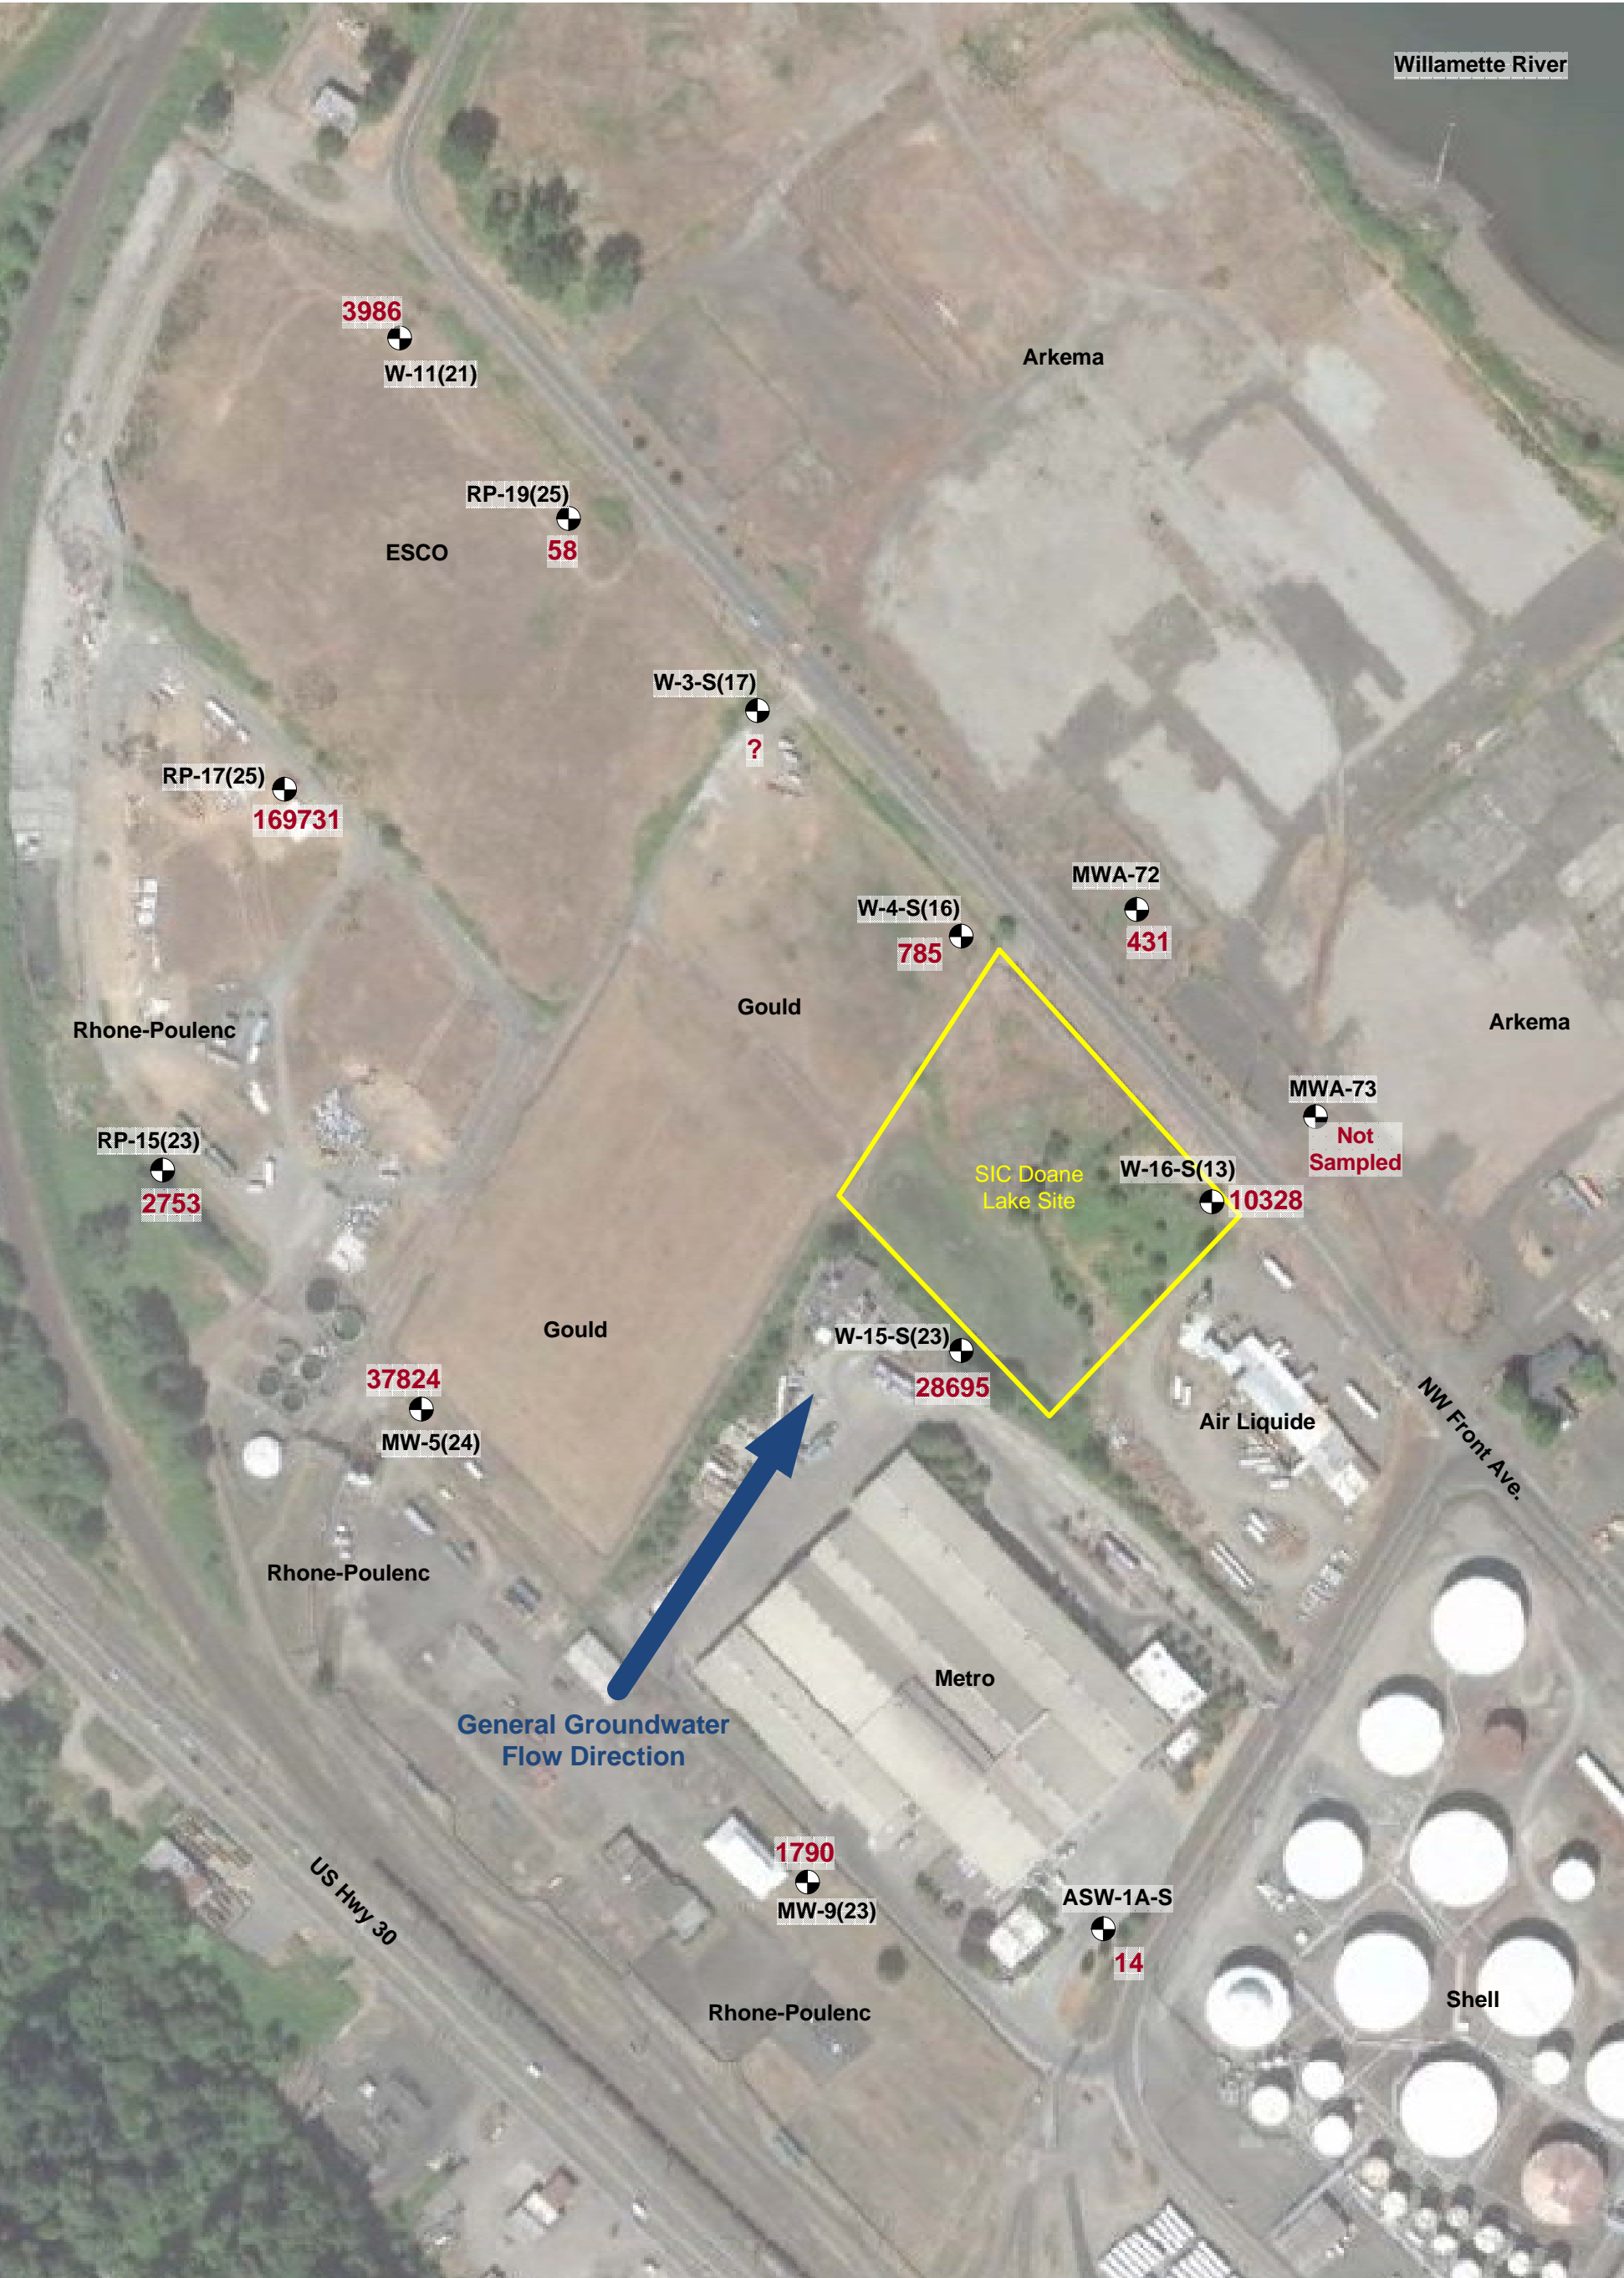
Figure 6b
PCB Concentrations in Groundwater Fill/Shallow Zone
Schnitzer Investment Corp. Doane Lake
BRIDGEWATER GROUP, INC.

Fill/Shallow Zone (Figure 6b). In 2009, the monitoring well located at the Property cross gradient of the Shredder Residue area, screened at 13 feet bgs in the Fill/Shallow Zone (W-16-S), showed a concentration of 10,328 pg/L (summation of congeners).⁴ This concentration is lower than up-gradient well W-15 at Metro, screened at 23 feet bgs in the Fill/Shallow Zone, where PCBs were detected at 28,695 pg/L, which is approximately three times the PCB concentration in W-16-S. MWA-72 which is screened in the Fill/Shallow Zone and down-gradient of the Property at the Arkema property, showed a concentration of 431 pg/L in 2010. The JSCS SLV is 64 pg/L. Well MWA-72 is 1,000 feet from the river.

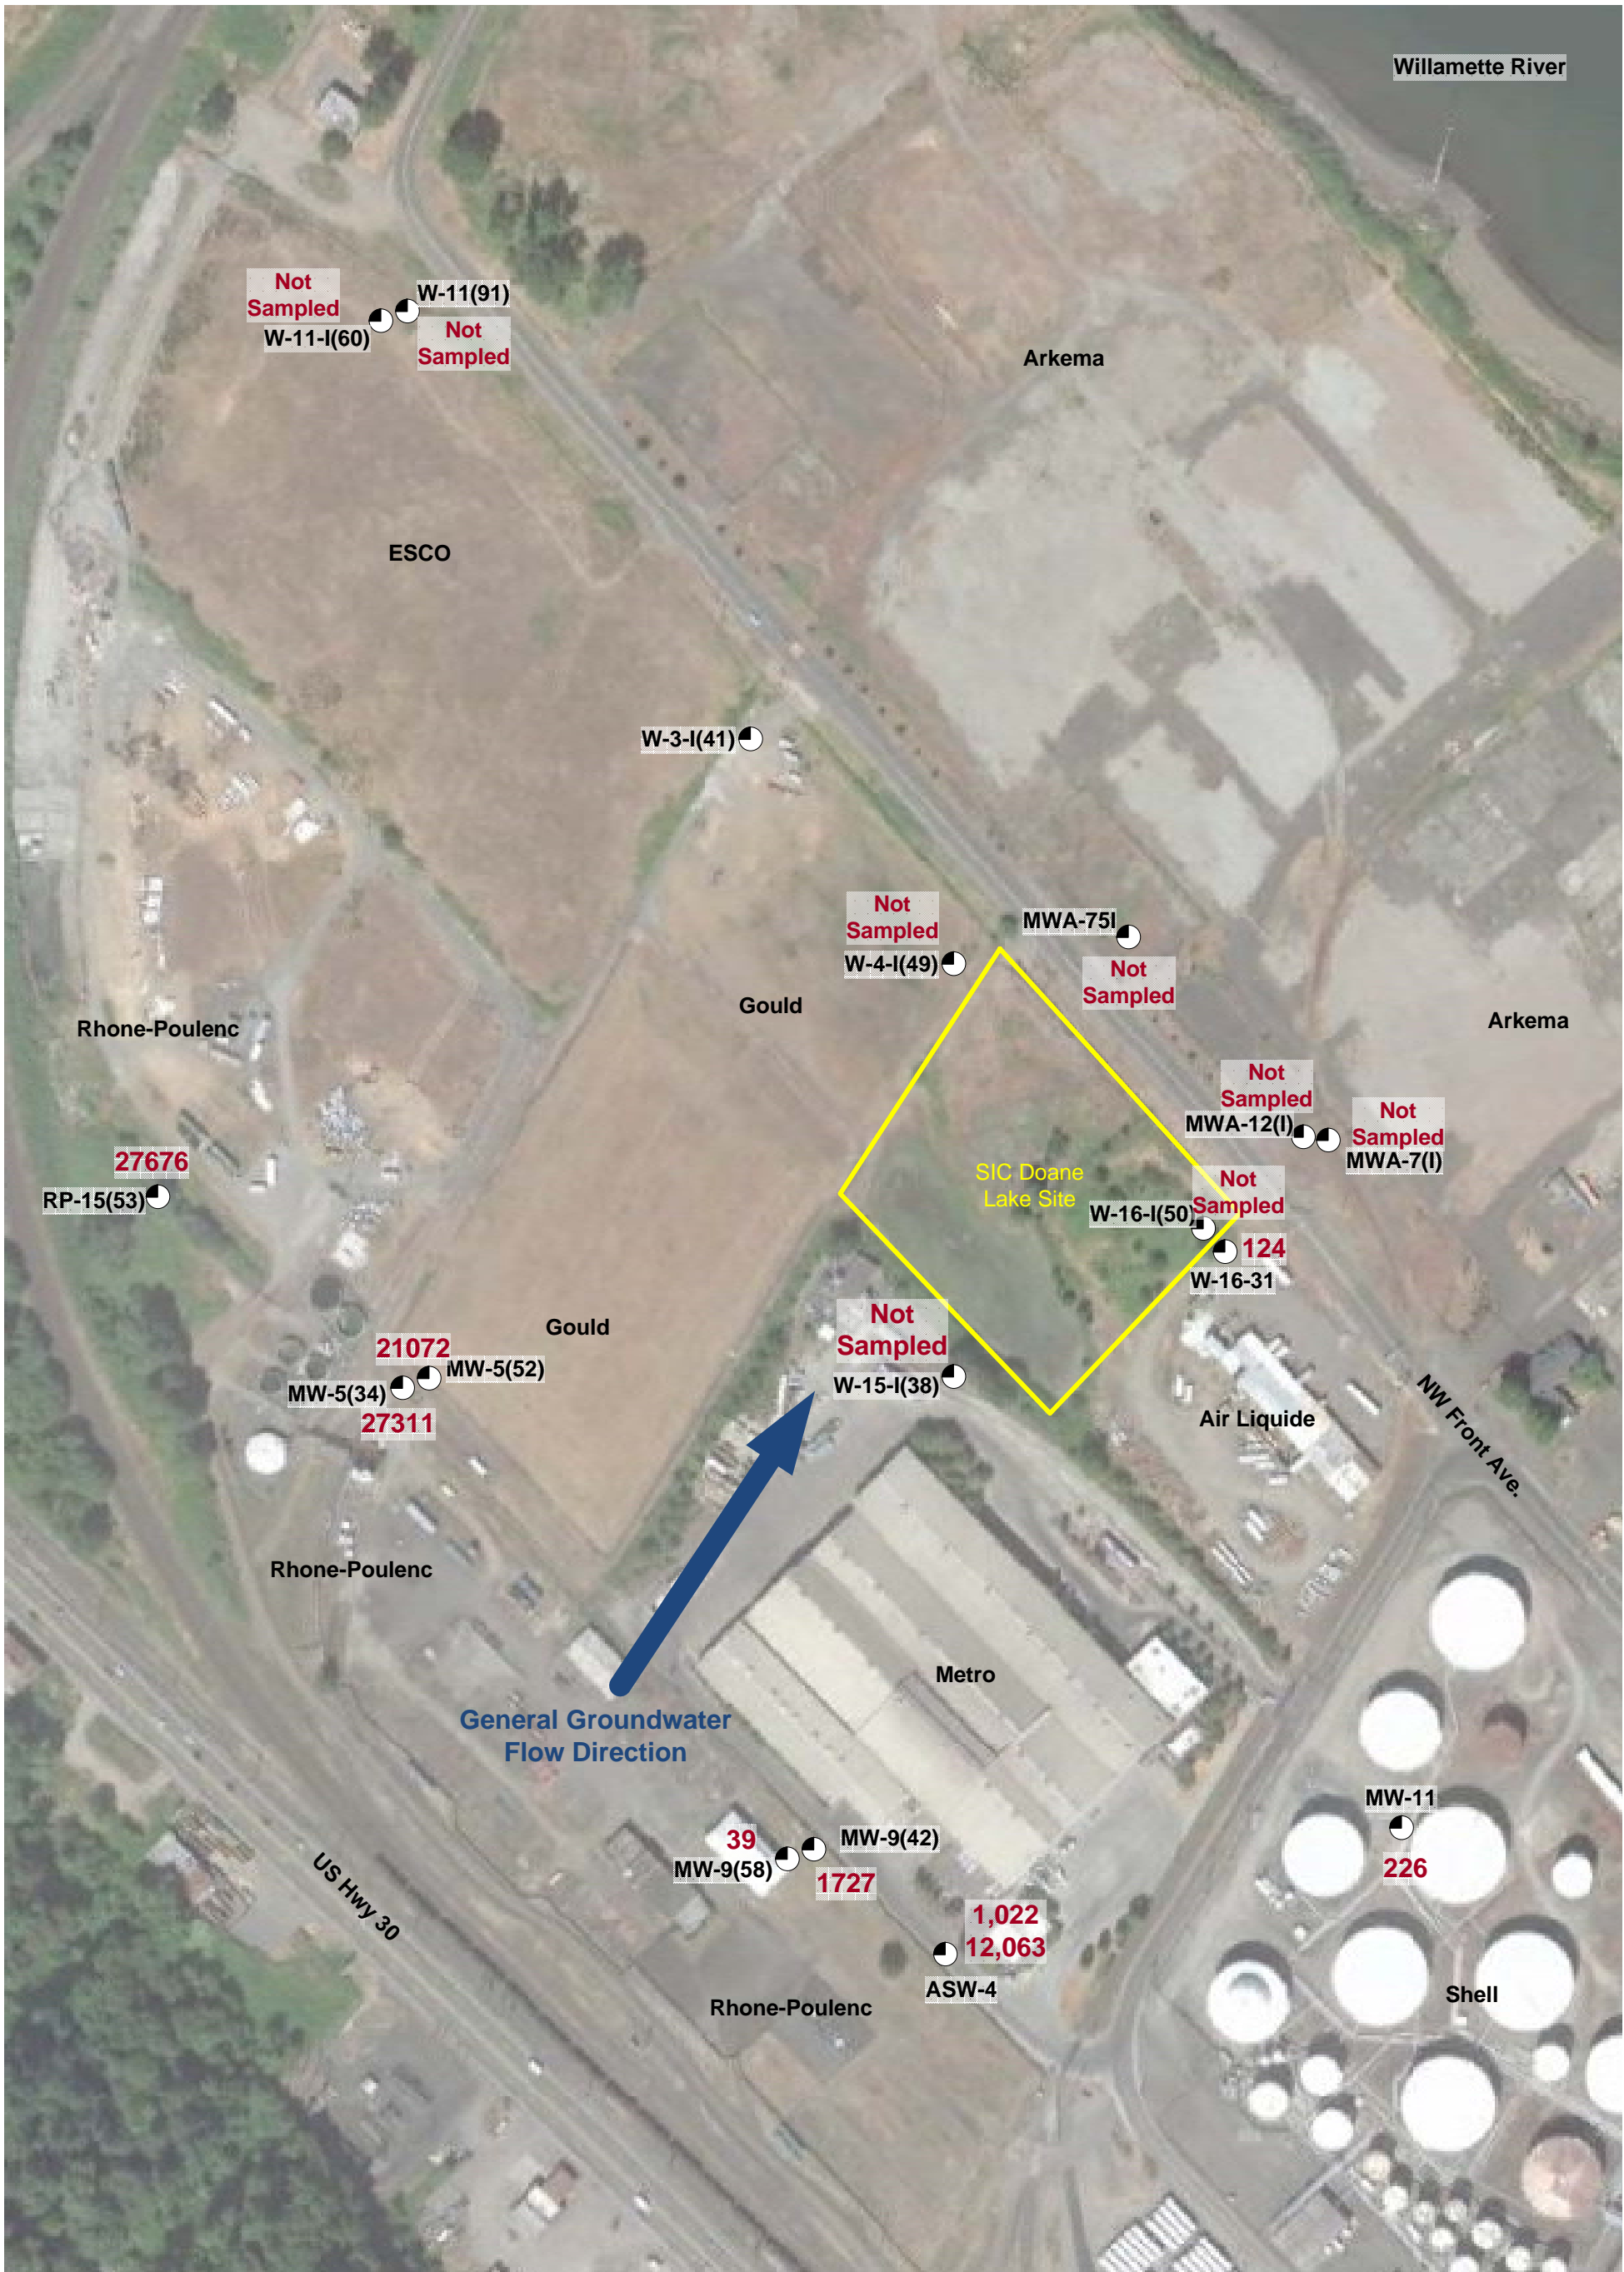
Figure 6c
PCB Concentrations in Groundwater Intermediate/Alluvium Zone
Schnitzer Investment Corp. Doane Lake

Intermediate/Alluvium Zone (Figure 6c). According to the sampling data for each location, the monitoring well W-16-31 on the subject Property, screened at 31 feet bgs in the Alluvium Zone and located at the Property cross gradient of the Shredder Residue area, showed a concentration of 124 pg/L, which is slightly above the JSCS SLV of 64 pg/L. In comparison, concentrations in up-gradient and cross-gradient wells in the same hydrogeologic zone were all higher. Monitoring well MW-05-34, cross-gradient and potentially up-gradient from the Property and screened at 34 feet bgs in the Alluvium Zone, detected PCBs at 27,300 pg/L. Monitoring well MW-05-52, also potentially up-gradient from the Property and screened in the Alluvium Zone at 52 feet bgs, detected PCBs at 21,072 pg/L.
